Release Notes:

Version ST.1.0.090603 Software

for the HP ProCurve Threat Management Services zl Module

5900-0224
June 2009

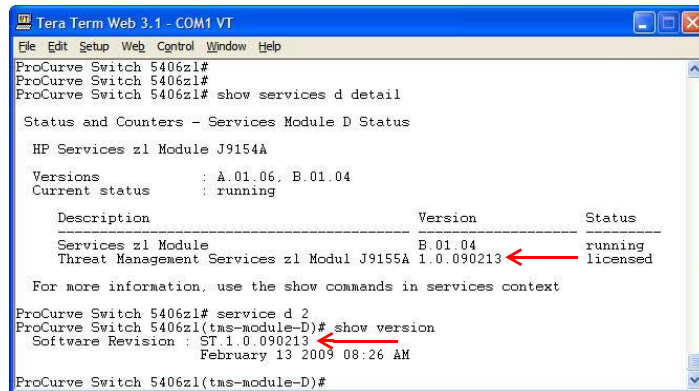
PR_41849/PR_41855 — After upgrading, the switch command line reports the first installed TMS z1 Module software version (ST.1.0.090213) rather than the updated version (ST.1.0.090603)

When the TMS z1 Module is running ST.1.0.090213, the following behavior is observed:

The output of the switch CLI command, **show services <slot-ID> detail**, and the output of the TMS z1 Module CLI command, **show version**, are both correct.

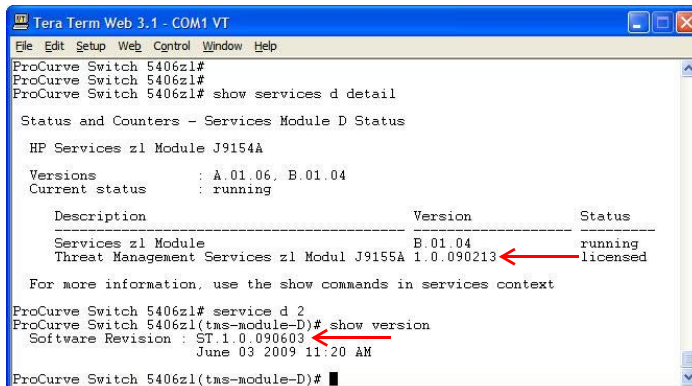
After the TMS zl Module has been updated to ST.1.0.090603, the following behavior is observed:

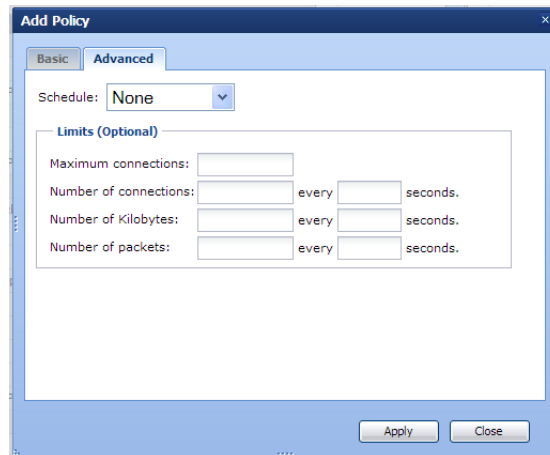
The valid range for entries in **connections**, **Kilobytes**, **packets**, and **seconds** are not listed. The valid ranges are 1 - 4294967295 for all fields except **Kilobytes**, which is 1 - 4194304.
